# MARYLAND INVENTORY OF HISTORIC PROPERTIES HISTORIC BRIDGE INVENTORY MARYLAND STATE HIGHWAY ADMINISTRATION MARYLAND HISTORICAL TRUST

NAME AND SHA NO.: 1042

LOCATION         Road Name and Number:       MD 47 over North Branch of Jennings Run         City/Town:       Barrelville       X vicinity         County:       Allegany	
Ownership: X State County Municipal Other	
Bridge projects over: _ Road _ Railway X Water _ Land	
Is bridge located within designated district?: _ yes X no  NR listed district _ NR determined eligible district locally designated other Name of District	
BRIDGE TYPE	
Timber Bridge Beam Bridge Truss-Covered Trestle Timber-and-Concrete	
Stone Arch Bridge	
Metal Truss Bridge	
Moveable Bridge Swing Bascule Single Leaf Bascule Multiple Leaf Vertical Lift Retractile Pontoon	
Metal Girder Rolled Girder Rolled Girder Concrete Encased Plate Girder Plate Girder Concrete Encased	
Metal Suspension	
Metal Arch	
Metal Cantilever	
X Concrete Concrete Arch Concrete Slab X Concrete Beam Rigid Frame Other Type Name

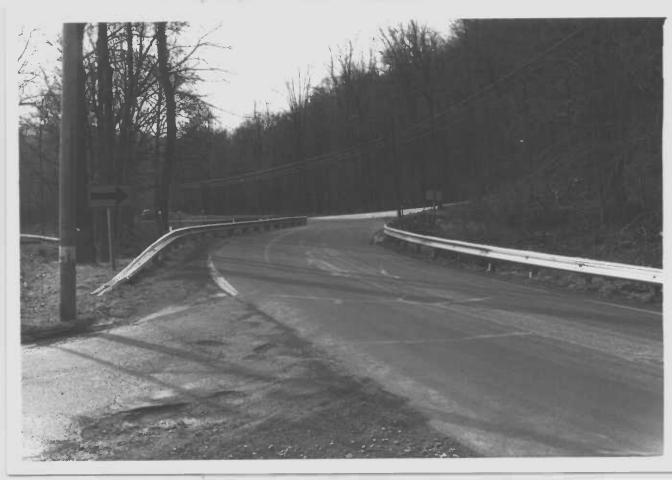
10 F 4

SOUTH APPROACH

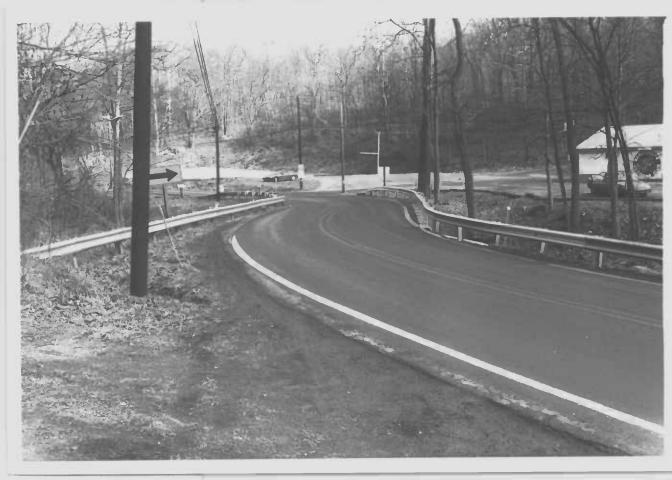
2 OF 4

NORTH APPROACH

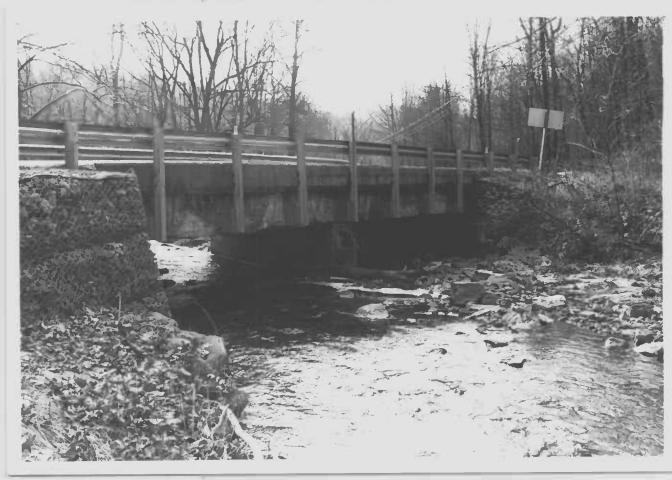
3 OF 4

WEST ELEVATION (UPSTREAM)

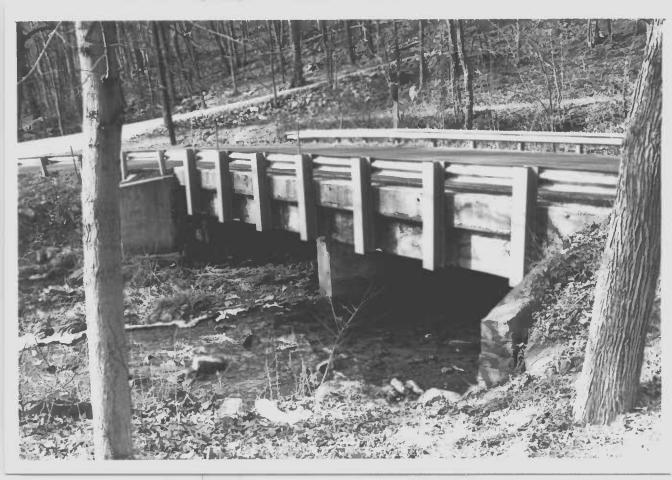
4 OF 4

EAST ELEVATION (DOWNSTREAM)
